ECO INSPECTION REPORT

10 / 01 / 2021

Audi A4 Premium Plus, 2019

| Year | 2019 | Registration No. | DL10CG3657 |

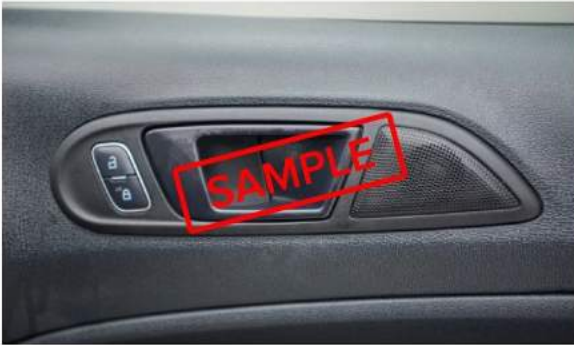
CENTRAL LOCK

Remarks: Central Lock Not Working
Repair Estimate: ₹ 600

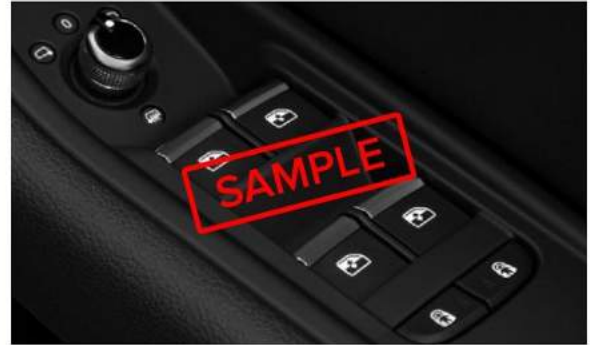
POWER WINDOW

Remarks: Power Window Not Working
Repair Estimate: ₹ 600

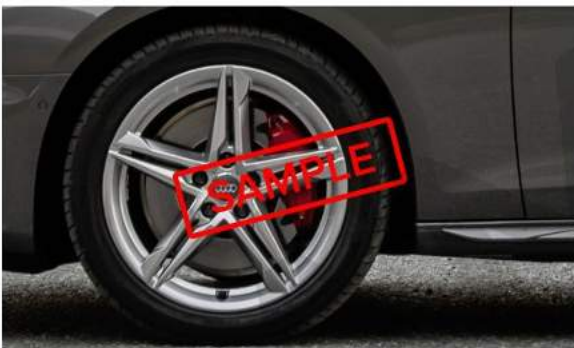
FRONT TYRES

Remarks: Front tyres are not in a good condition
Repair Estimate: ₹ 600

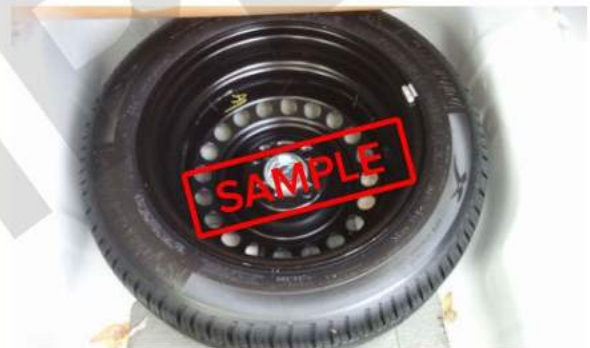
SPARE TYRES

Remarks: Spare tyres are not in a good condition
Repair Estimate: ₹ 600

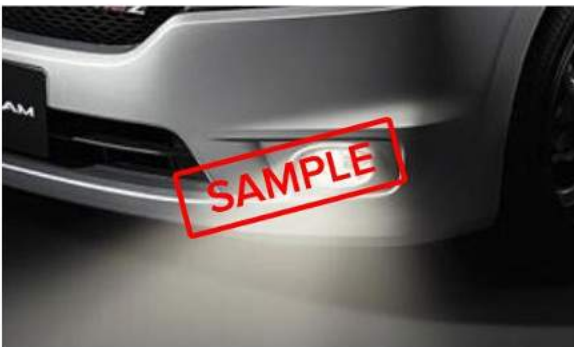
FOG LAMPS

Remarks: Major cracks in Fog Lamps
Repair Estimate: ₹ 900

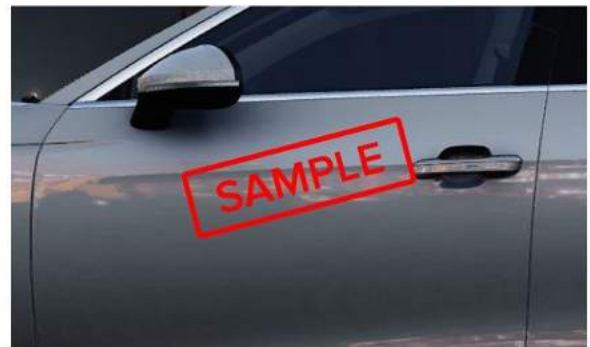
LEFT FRONT DOOR

Remarks: Scratches/Dents in Front Door
Repair Estimate: ₹ 900
